PRE-PRODUCTION ENGINEERING AND CERTIFICATION OF FIOVALVE BACKWATER VALVE

August 1987

Anderson Associates
Consulting Engineers Inc.

Fiodrain Ltd.

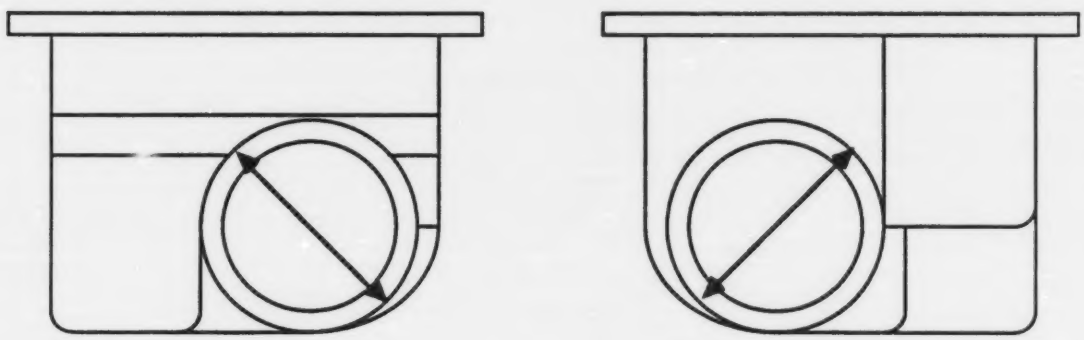
All spigots, except for the outlet of sample 2, failed for being undersize and exceeding the out-of-roundness tolerances. The orientation of the maximum and minimum diameters with respect to the body geometry was consistent for all samples as shown in Figure 5. The minimum and maximum diameters occurred at approximately right angles to one another. One might note that the modified spigots were only 0.01 to 0.03 mm (0.0008 to

Figure 5: Residual stresses due to the differential cooling and asymmetric body geometry distort the spigots out-of-round. The minimum diameter shown by the arrows occurs where the body stiffens the spigots the least. The maximum diameter occurs at right angles to the arrows which represents the direction of greatest stiffness.

Considering the mold first, the end core blocks which form the upper half of the spigots were not true half circles as required and the centrelines were slightly non-coincident. Since the core blocks could be removed from the main mold, correction of these deficiencies could be performed in a milling

The inlet and outlet core blocks were machined to match the half diameters in the fixed platen at Szantech Machine Tools Inc. After reassembly, the inlet and outlet bores were measured at 115.32 ± 0.03 mm in diameter or essentially within the tolerance limits of the repair method employed.

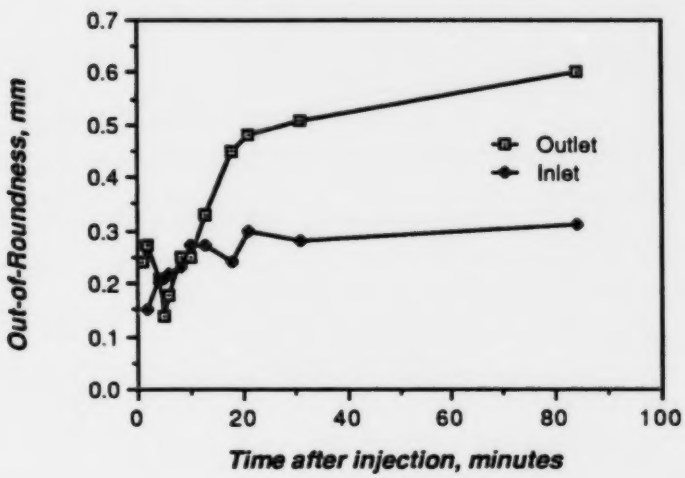
conditions. In some cases, acceptable spigots when measured an hour after injection were satisfactory but were later rejected due to excessive out-of-roundness tolerance when measured several hours later or the next day. This confirms the large magnitude of the residual stresses since the distortion occurred after the parts had essentially attained a common temperature and strength. In these cases, the distortion represented creep under a high stress loading.

Empirically, longer injection times with higher injection temperatures were found to produce castings that beco e stable after about 1 1/2 hours. Figure 6 shows the time-dependent distortion as indicated by out-of-roundness for a sample injected in trial 10 which remained stable when measured 16 hours later.

Figure 6: Typical distortion of the spigots (measured at the extreme ends) as a function of time after injection.

Since residual stresses which developed during cooling appeared responsible for the distortion, attempts were made to modify the mold's heat transfer pattern by introducing warm water to certain portions of the mold. The water cooling passages in the mold allow a large number of water flow combinations. However, simply separating the female core block from the end and the male core blocks provided satisfactory results. Warm 120°F
